# LEVEL II CORROSION OF 5456-H117 ALUMINUM IN HIGH VELOCITY SEAWATER

By G. A. GEHRING, JR.

Prepared for OFFICE of NAVAL RESEARCH

June 1978

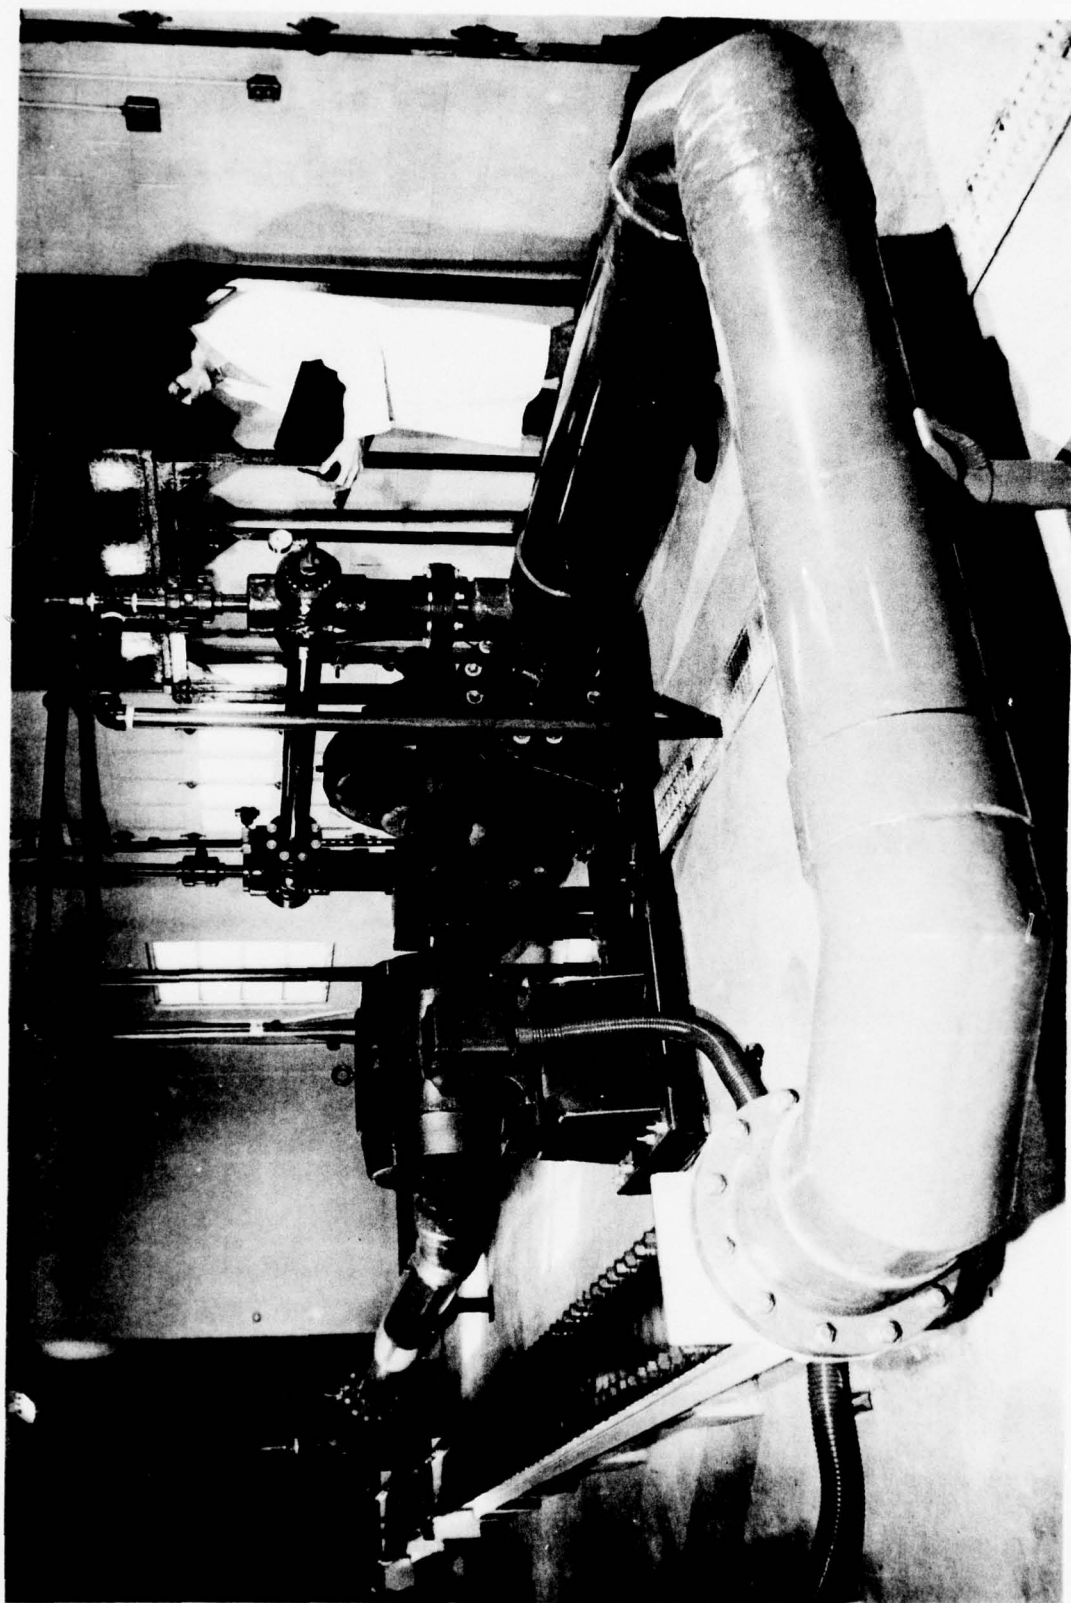
Figure 1  
High Velocity Flow Channel

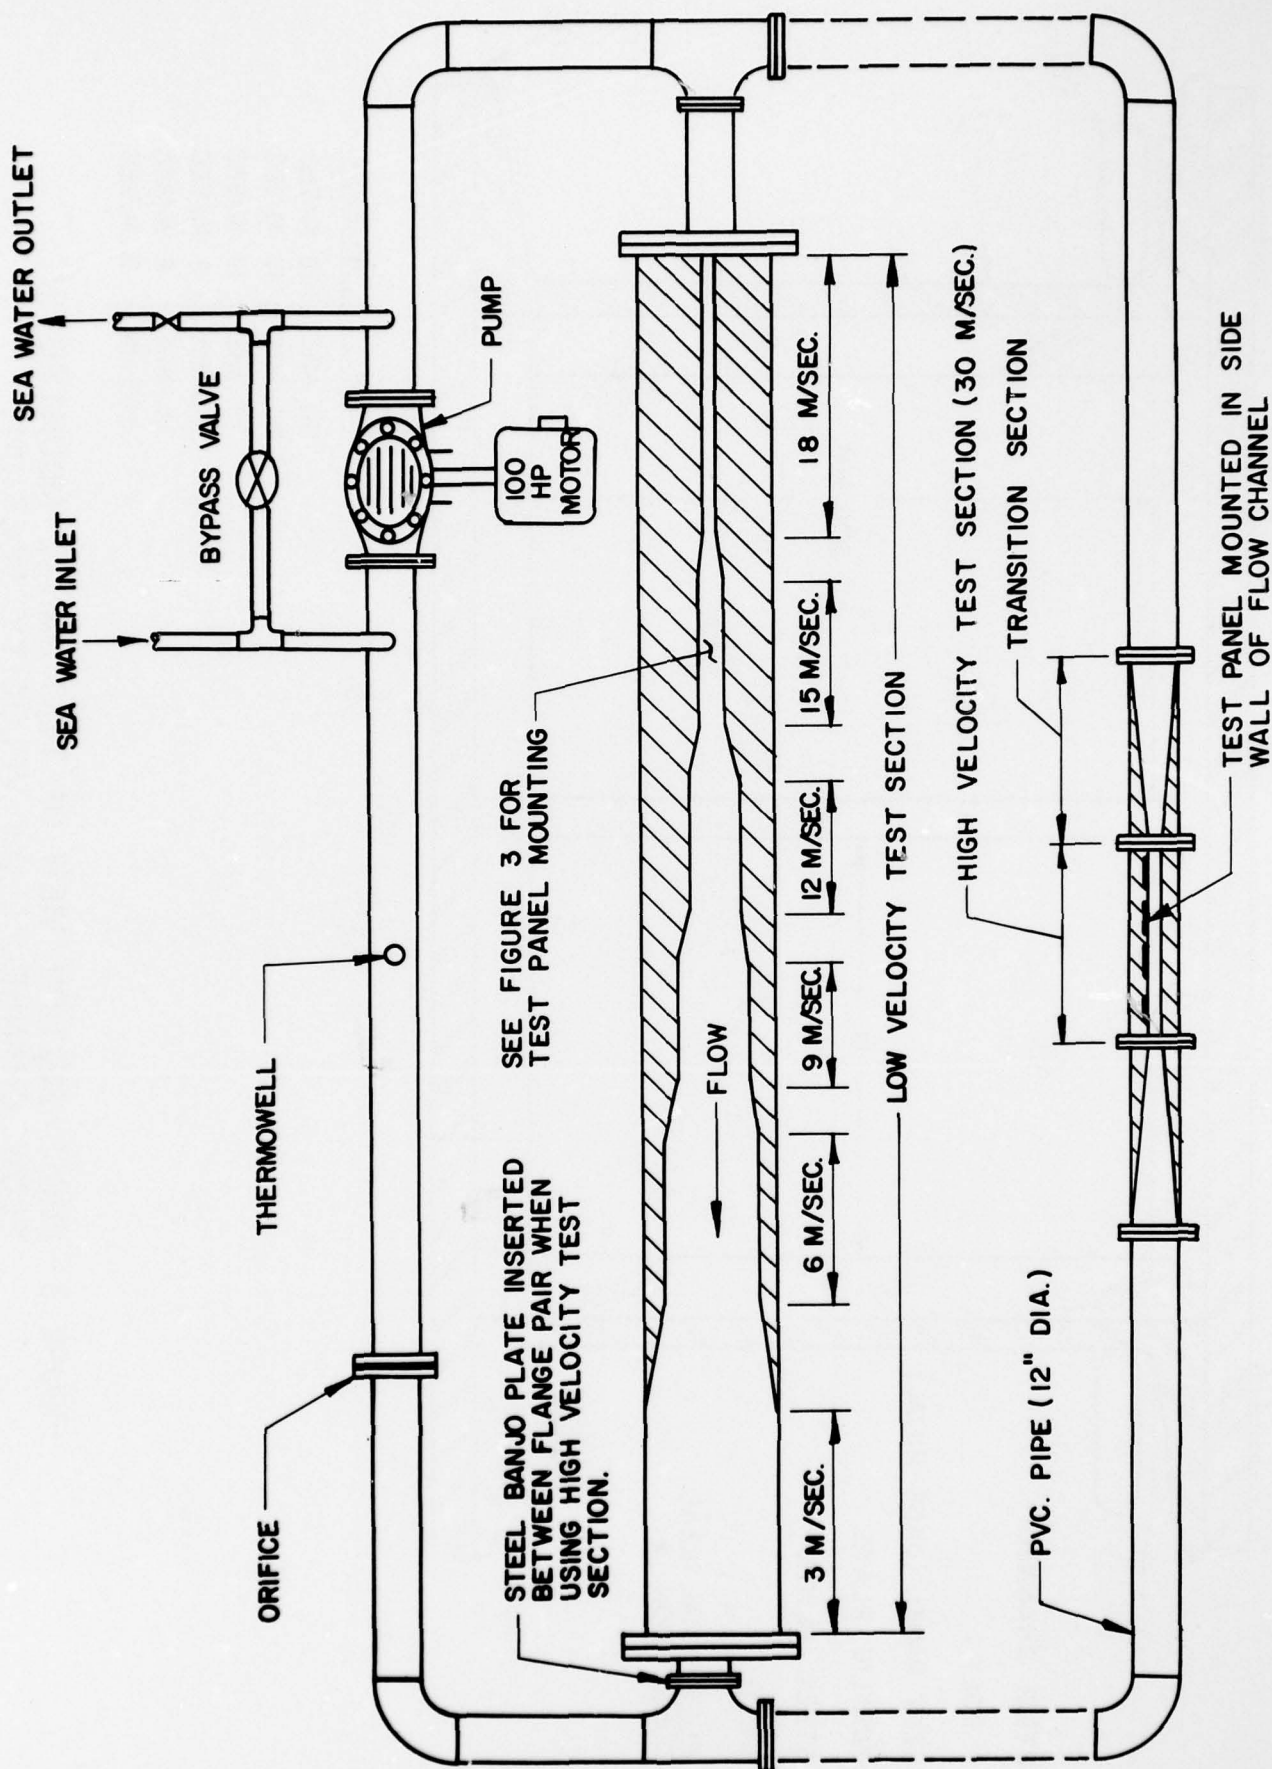
FIGURE 2—SIMPLIFIED SCHEMATIC OF FLOW CHANNEL

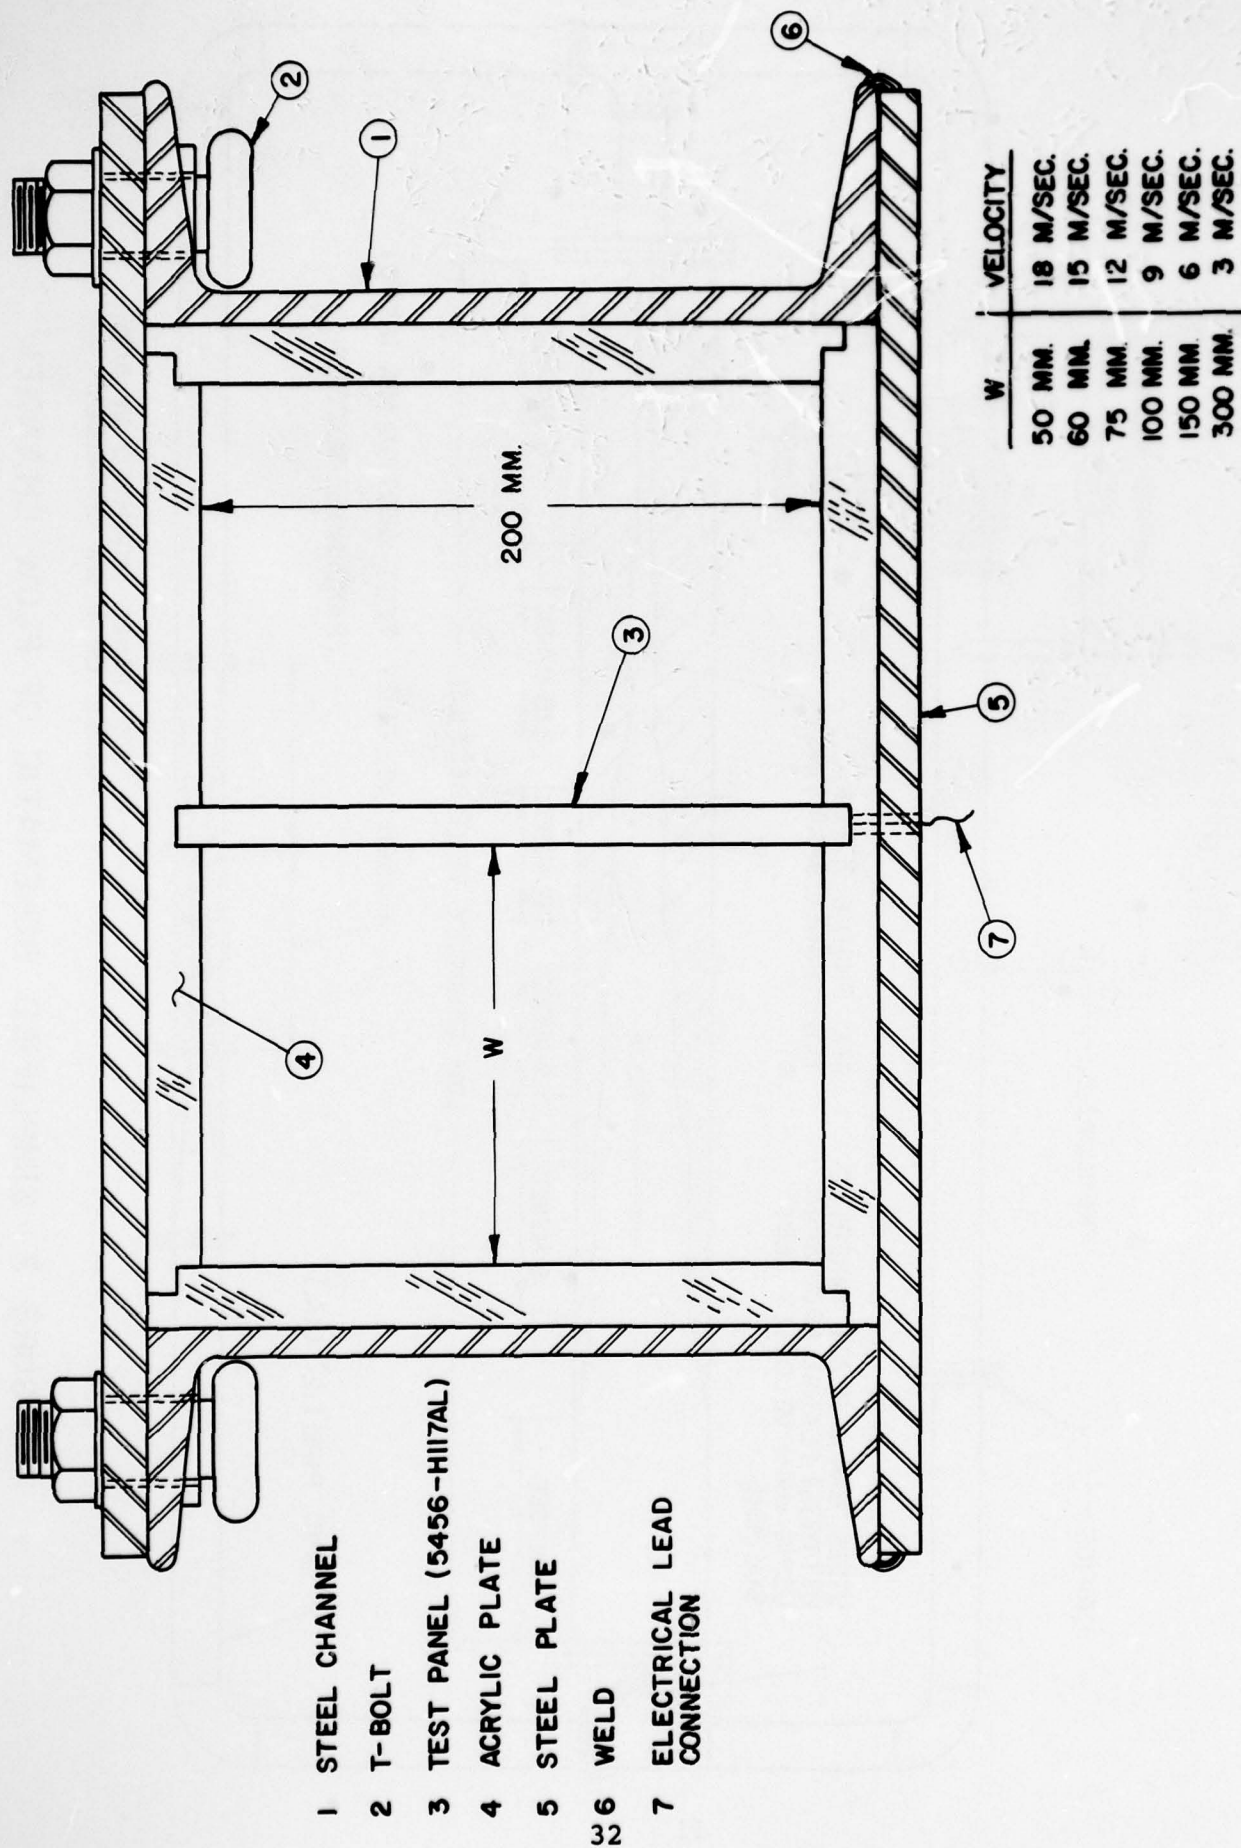
FIGURE 3 - CROSS-SECTION VIEW OF TEST PANEL MOUNTED IN FLOW CHANNEL (LOW VELOCITY SECTION)

In the high velocity section (30 m/s), the test panels were fitted into slots which had been precisely machined in the acrylic sidewalls. The test panels were carefully shimmed to minimize edge mismatch and eliminate cavitation. The panels were also seated in a thin layer of potting compound to prevent crevice corrosion effects. As in the low velocity section, provisions were made for external electrical connection to the panels to permit the acquisition of electrochemical data.

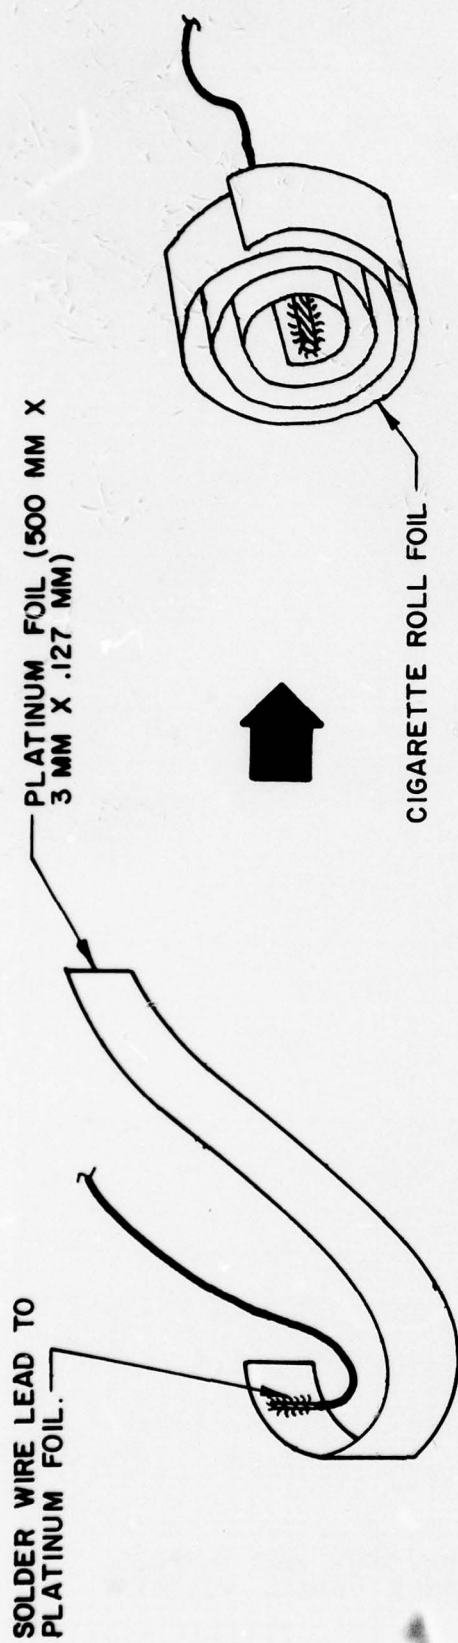
FIGURE 4 --PREPARATION AND MOUNTING OF PLATINUM ELECTRODES

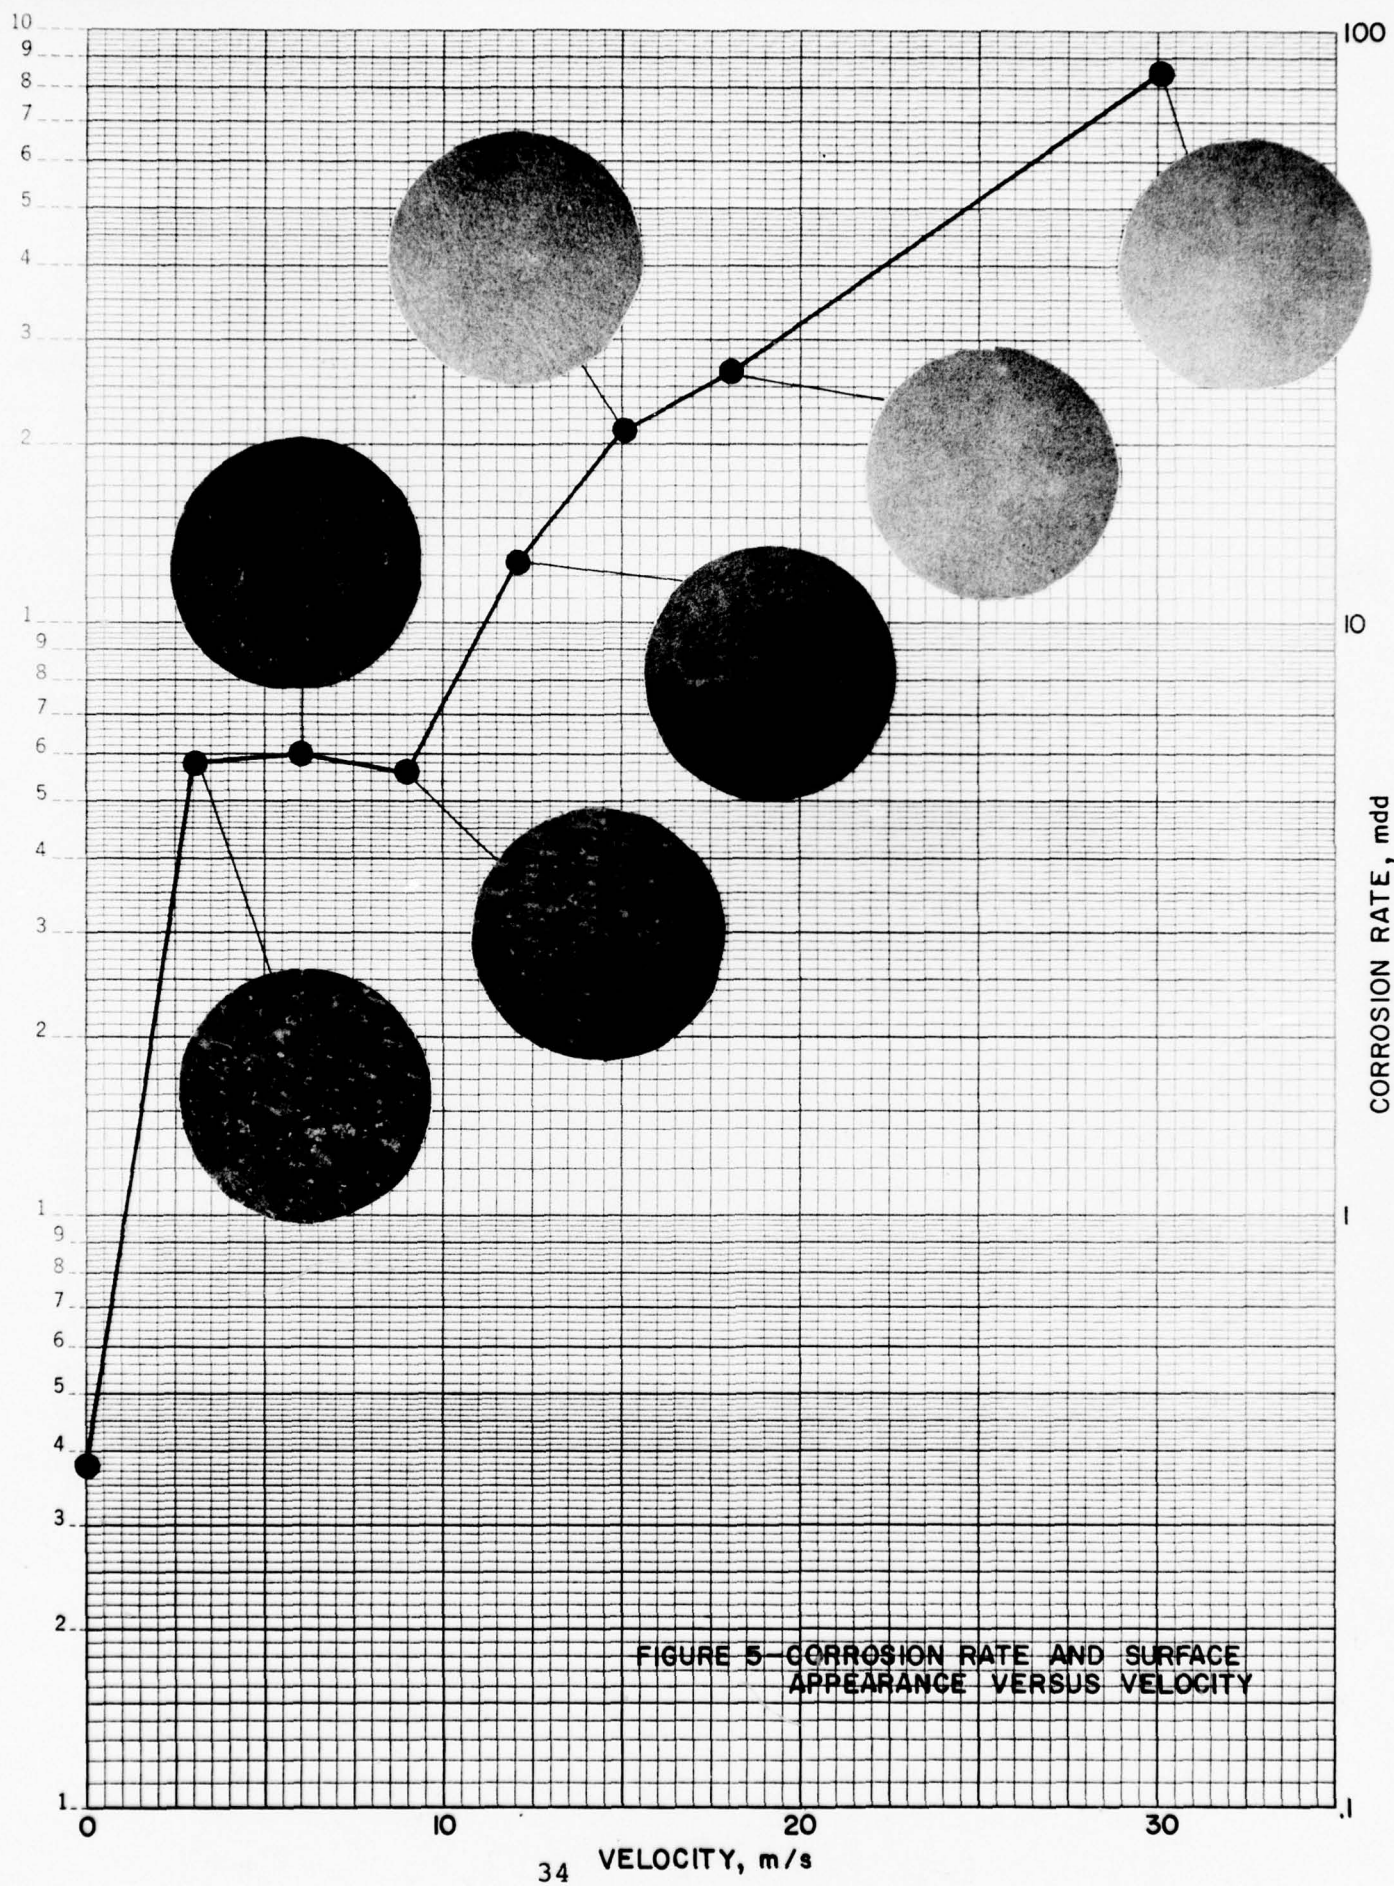
FIGURE 5—CORROSION RATE AND SURFACE APPEARANCE VERSUS VELOCITY

Figure 5 shows the change in corrosion rate versus velocity along with pictorial inserts showing the corresponding change in surface appearance for the 5456 aluminum alloy. The

corrosion rates were determined by weight loss after 35 days exposure (20 days exposure at 30 m/s). At high velocities, the surfaces appeared smooth and shiny while at the lower velocities the test panels were encrusted with a combination corrosion product/slime film. The observed changes in surface morphology are more fully discussed later in this report. The corrosion rate in quiescent seawater was 0.37 mdd and increased to about 6 mdd at the lowest channel velocity examined, 3 m/s. The corrosion rate was relatively constant over the velocity range of 3 to 9 m/s, then increased continuously to 83 mdd at 30 m/s. The sharp increase in corrosion rate at velocities above 9 m/s suggests the existence of a threshold or "breakaway" velocity similar to that observed by Efird<sup>2</sup> for copper-nickel alloys. Efird proposed that as increasing velocity causes a corresponding increase in hydrodynamic shear stress, a point is reached where the fluid shear stresses are sufficient to disrupt the protective oxide film. This point occurs at the so-called breakaway velocity and is characterized by a sharp increase in corrosion rate.

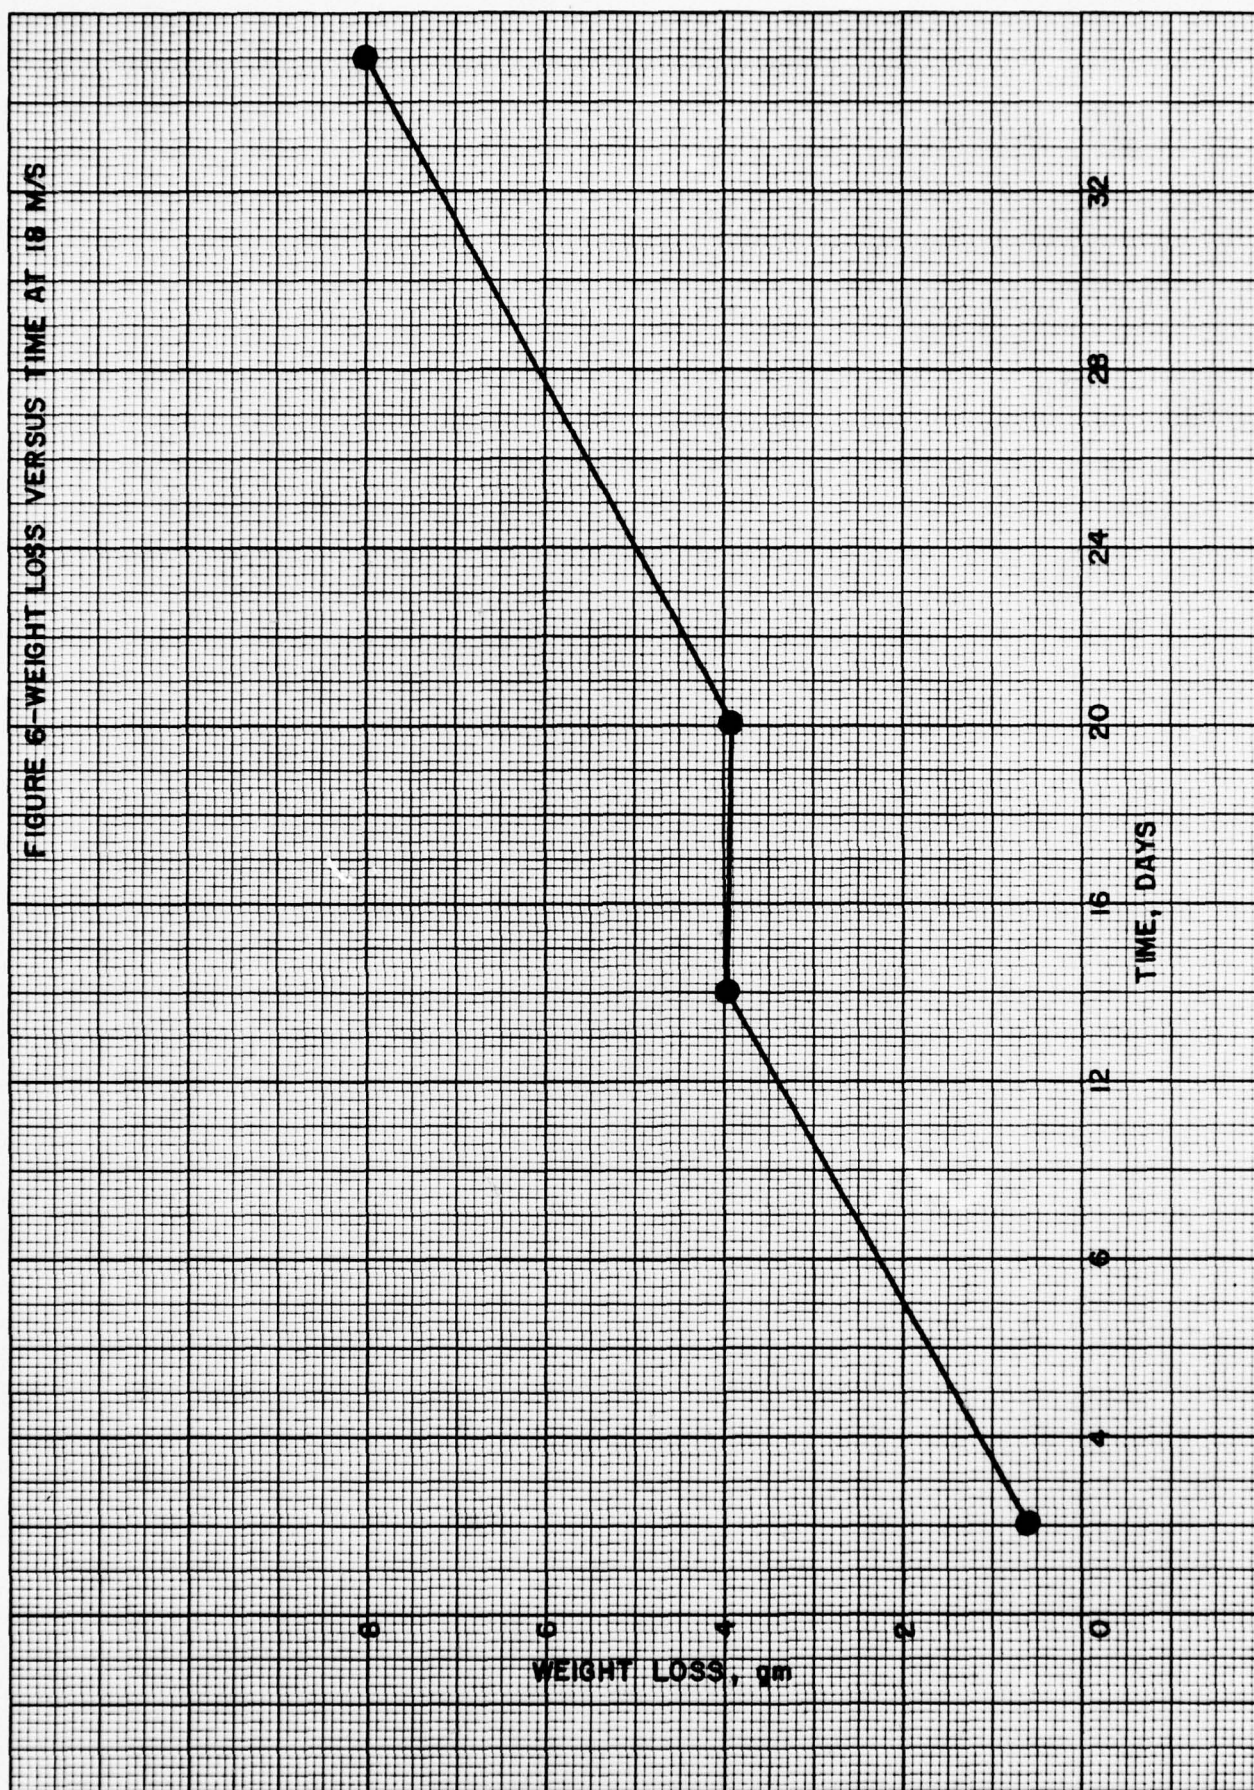
FIGURE 7-CORROSION RATE AND SURFACE APPEARANCE  
VERSUS TIME AT 18 M/S

A series of panels were exposed at 18 m/s for various time periods and the corrosion rate determined by weight loss measurements. These tests were conducted in order to determine the time required to establish steady state conditions. Figure 6 shows the weight loss as a function of time on the 5456 aluminum alloy and Figure 7 shows the corresponding corrosion rates and surface appearance. The results indicate that a steady-state corrosion rate was achieved after two days at this velocity. However, it required closer to 20 days to achieve an apparent steady-state surface appearance. Based on these results, it appears

that steady-state corrosion rates are achieved very rapidly above the 9 m/s threshold velocity, while the characteristic surface appearance takes considerably longer to develop.

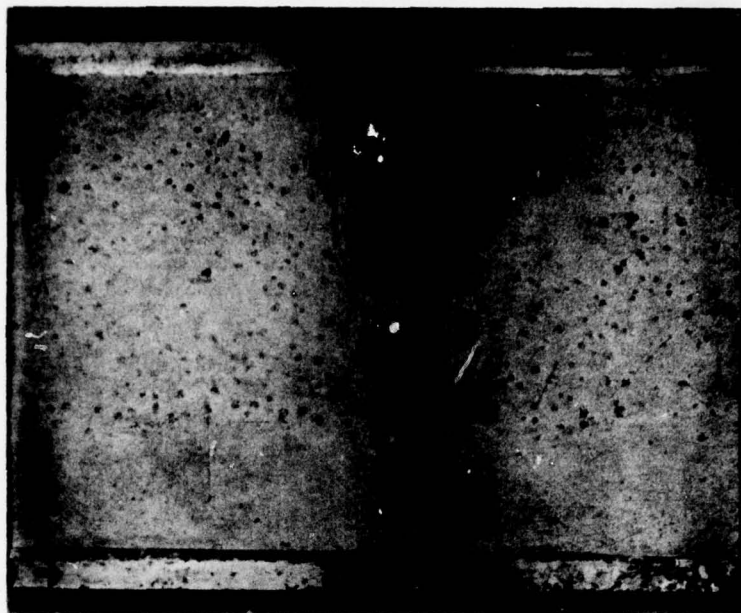
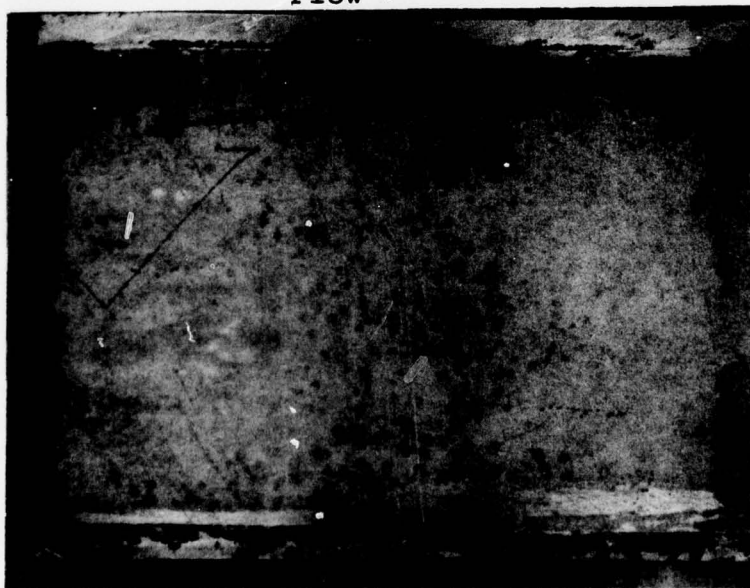
Figure 8a - Macroscopic Appearance of Test Panel After 2 Days Exposure at 18 m/s

Figure 8b - Macroscopic Appearance of Test Panel After 2 Days Exposure at 9 m/s

Figure 8c - Macroscopic Appearance of Test Panel After 2 Days Exposure at 3 m/s

Figure 8d - Macroscopic Appearance of Unexposed Test Panel

panel for comparison. All of the panels exhibited a mottled appearance after 2 days at velocity. Higher magnification micrographs (Figures 9a thru 9c) suggested that the hydrated oxide outer layer was being removed at the higher velocities, whereas at the lower velocity there appeared to be localized building or accumulation of corrosion products. Although different phenomena seemed to be occurring at higher versus lower velocities, the resulting macroscopic appearance was similar.

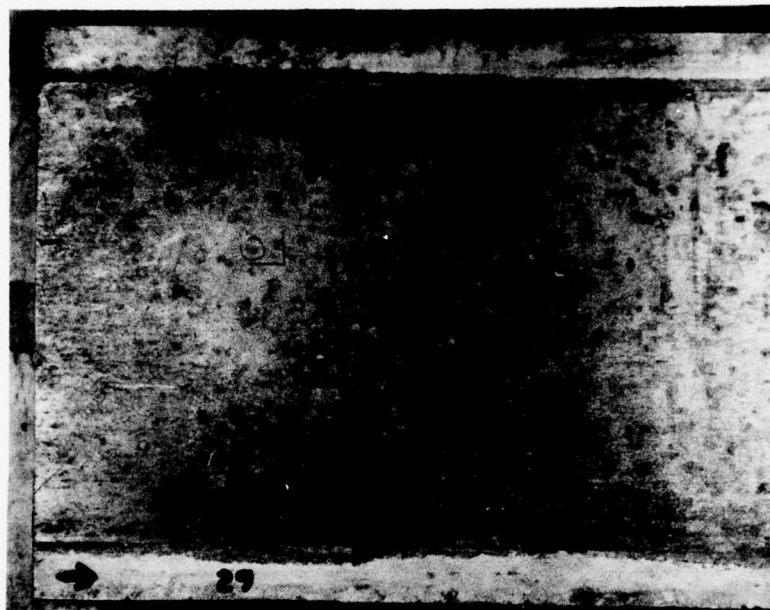
Figure 10a - Macroscopic Appearance of Test Panel After 14 Days Exposure at 18 m/s

Figure 10b - Macroscopic Appearance of Test Panel After 14 Days Exposure at 9 m/s

Figure 10c - Macroscopic Appearance of Test Panel After 14 Days Exposure at 3 m/s

Figures 10a thru 10c show the macroscopic appearance of test panels exposed at 3, 9 and 18 m/s. The test panels still exhibited a "mottled" appearance, which at higher magnification appeared as contrasting light and dark areas (Figure 11). The panel exposed at 3 m/s exhibited an accumulation of corrosion products in some areas with an apparently stable oxide film in the remaining areas. Small particles were barely visible on the panel exposed at 3 m/s. At 9 m/s, the small particles stood out in relief and at 18 m/s, the particles were even more evident. The particles were analyzed by EDX and appeared to be (Cr, Fe, Mn) Al<sub>6</sub> intermetallic compounds. These intermetallic particles are typical for the 5456 alloy. At 18 m/s, closer examination around the particles in the light areas showed crazing of the oxide layer downstream from the particles (Figure 12). Pitting occurred around the particles in dark areas, but crazing downstream of the particles was not observed.

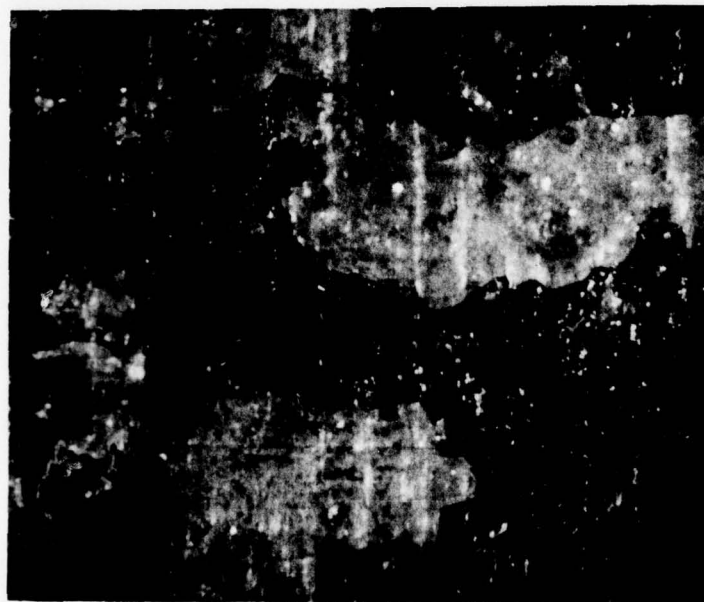
Figure 11a - Low Magnification (4.5x) Appearance of  
Test Panel After 14 Days Exposure at 18 m/s

Figure 11b - SEM Micrograph of Test Panel  
After 14 Days Exposure at 18 m/s (55x)

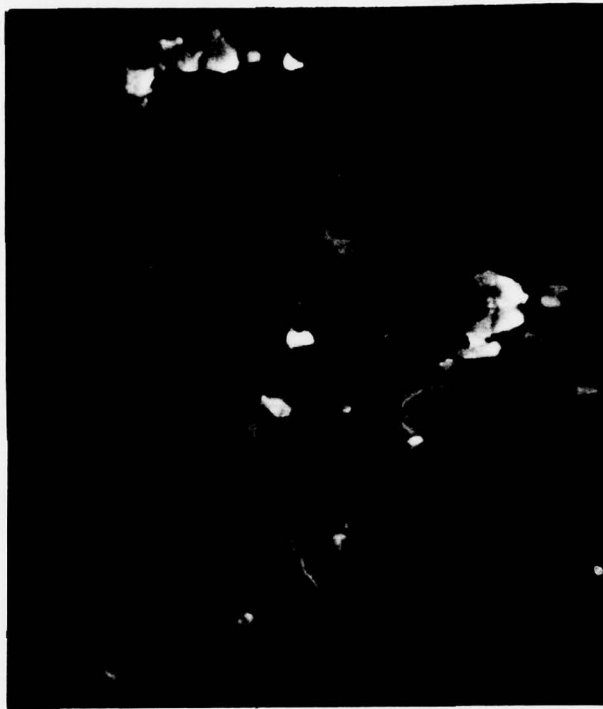
Figure 12a - SEM Micrograph Showing Crazing of  
Oxide Layer Downstream of Intermetallic  
Particles - 14 Days at 18 m/s (1000x)

Figure 12b - SEM Micrograph Showing Crazing of  
Oxide Layer Downstream of Intermetallic  
Particle - 14 Days at 18 m/s (1000x)

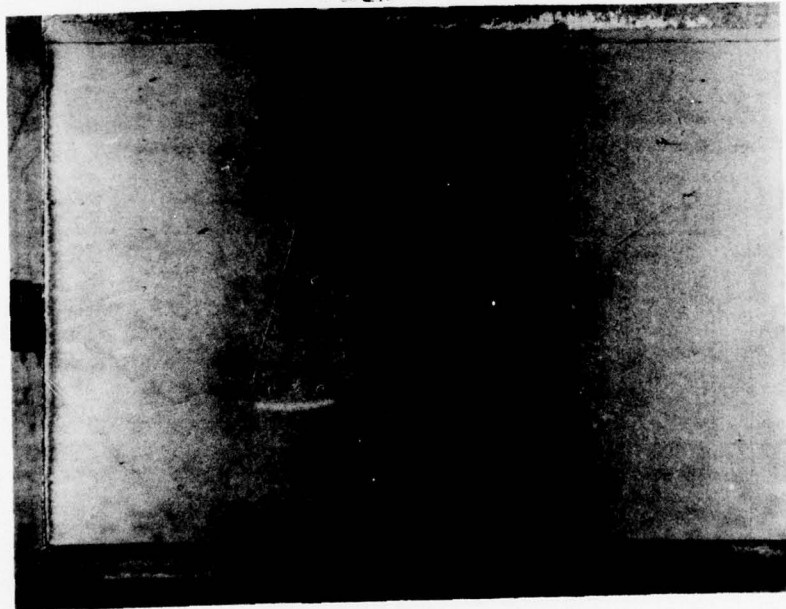
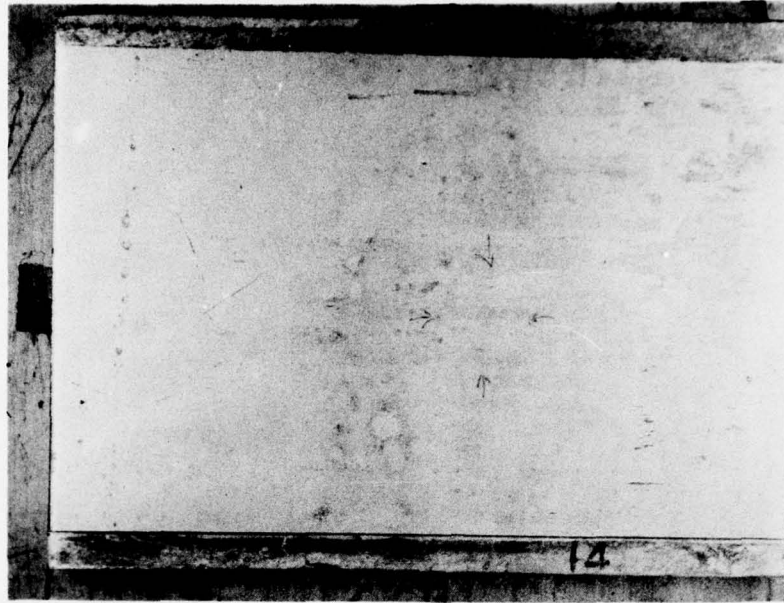
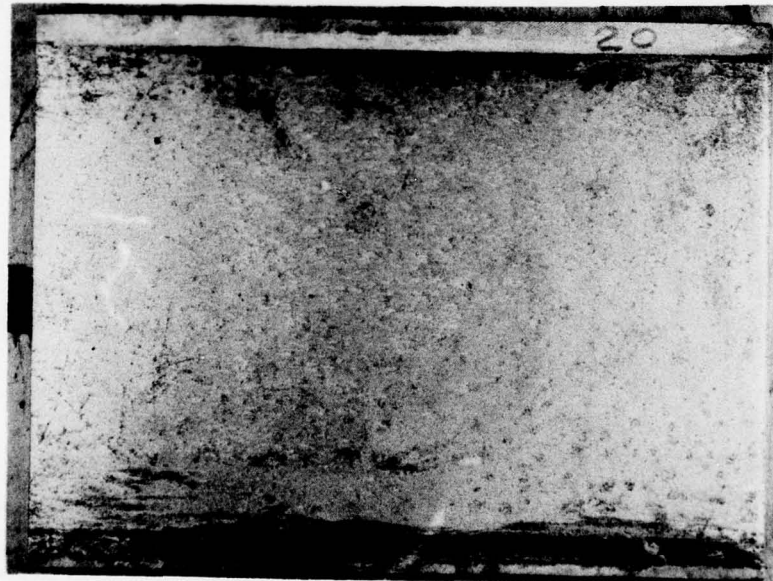
Figure 13a - Macroscopic Appearance of Test Panel After 35 Days Exposure at 18 m/s

Figure 13b - Macroscopic Appearance of Test Panel After 35 Days Exposure at 15 m/s

Figure 13c - Macroscopic Appearance of Test Panel After 35 Days Exposure at 12 m/s

Figure 13d - Macroscopic Appearance of Test Panel After 35 Days Exposure at 9 m/s

Figure 13e - Macroscopic Appearance of Test Panel After 35 Days Exposure at 6 m/s

Figure 13f - Macroscopic Appearance of Test Panel After 35 Days Exposure at 3 m/s

A striking contrast in surface appearance as a function of velocity was apparent on the panels removed after 35 days. Figures 13 and 14 show the typical macroscopic and low magnification appearance of panels exposed at 6 different velocities. At 3 m/s, the panels were encrusted with an uneven layer of corrosion products with small mounds of corrosion product evident at random locations on the surface. Pits were present at these locations after removal of corrosion products. The maximum pit depth approached 266 microns, while the average pit depth was approximately 130 microns. The panels at 18 m/s exhibited a smooth, highly reflective, glossy surface with no detectable corrosion products. The pitting intensity decreased with increasing velocity. Above 9 m/s, the visual corrosion attack appeared to have occurred uniformly, although subsequent high magnification examination would show micropitting at intermetallic particles. Table I presents the results of glossmeter measurements on the surface and confirms quantitatively the observed changes.

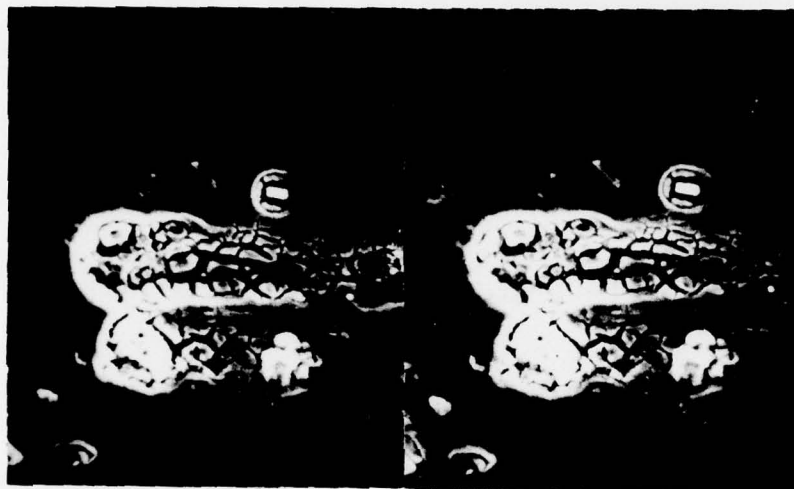
Figure 20 - SEM Stereo Micrograph Showing  
Preferential Pitting Downstream of Inter-  
metallic Particles - 35 Days Exposure at  
15 m/s (1000x)

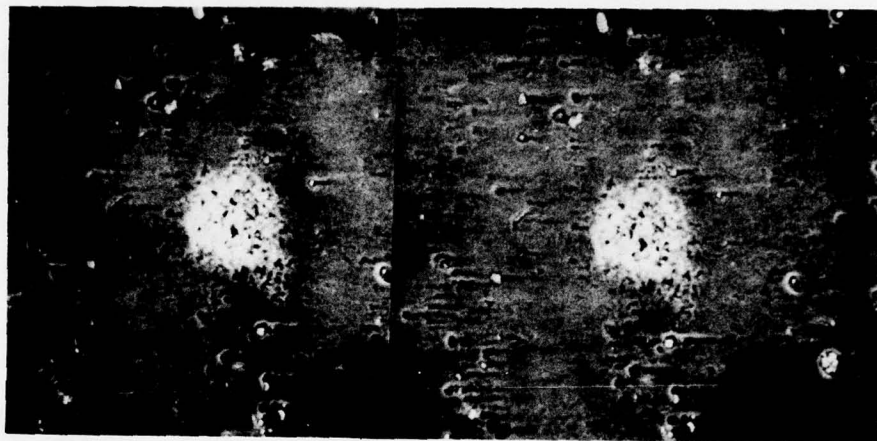
Figure 25 - SEM Stereo Micrograph Showing Random  
Macropit - 22 Days Exposure at 30 m/s (250x)

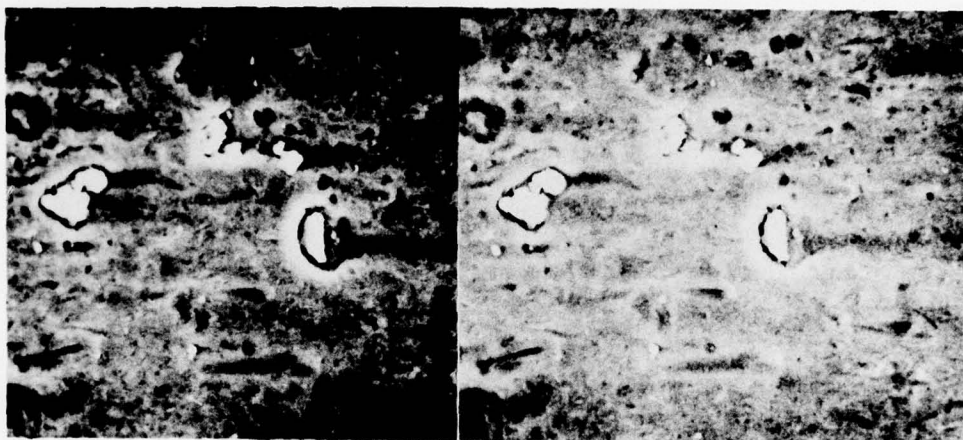
Figure 29 - SEM Stereo Micrograph Showing Micro-pitting and Preferential Attack Downstream of Intermetallic Particles - 22 Days Exposure at 30 m/s (1000x)

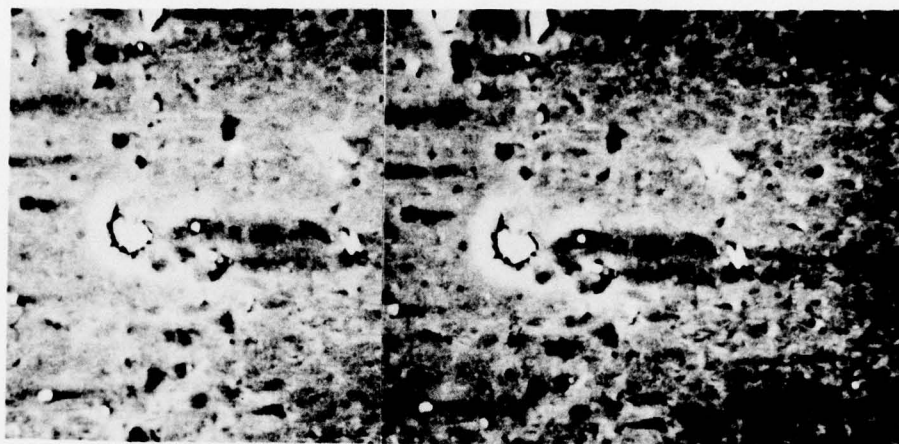
Figure 30 - SEM Stereo Micrograph Showing Micro-pitting and Preferential Attack Downstream of Intermetallic Particles - 22 Days Exposure at 30 m/s (1000x)

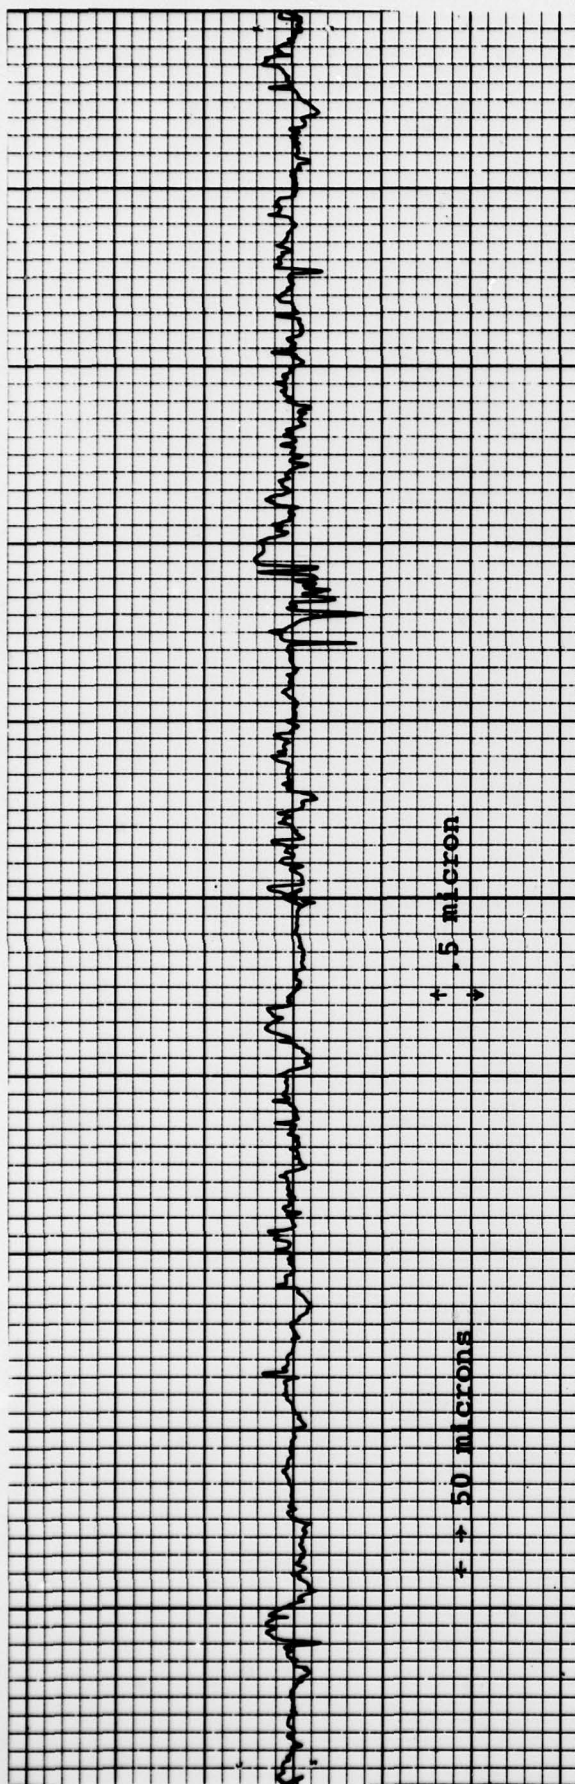
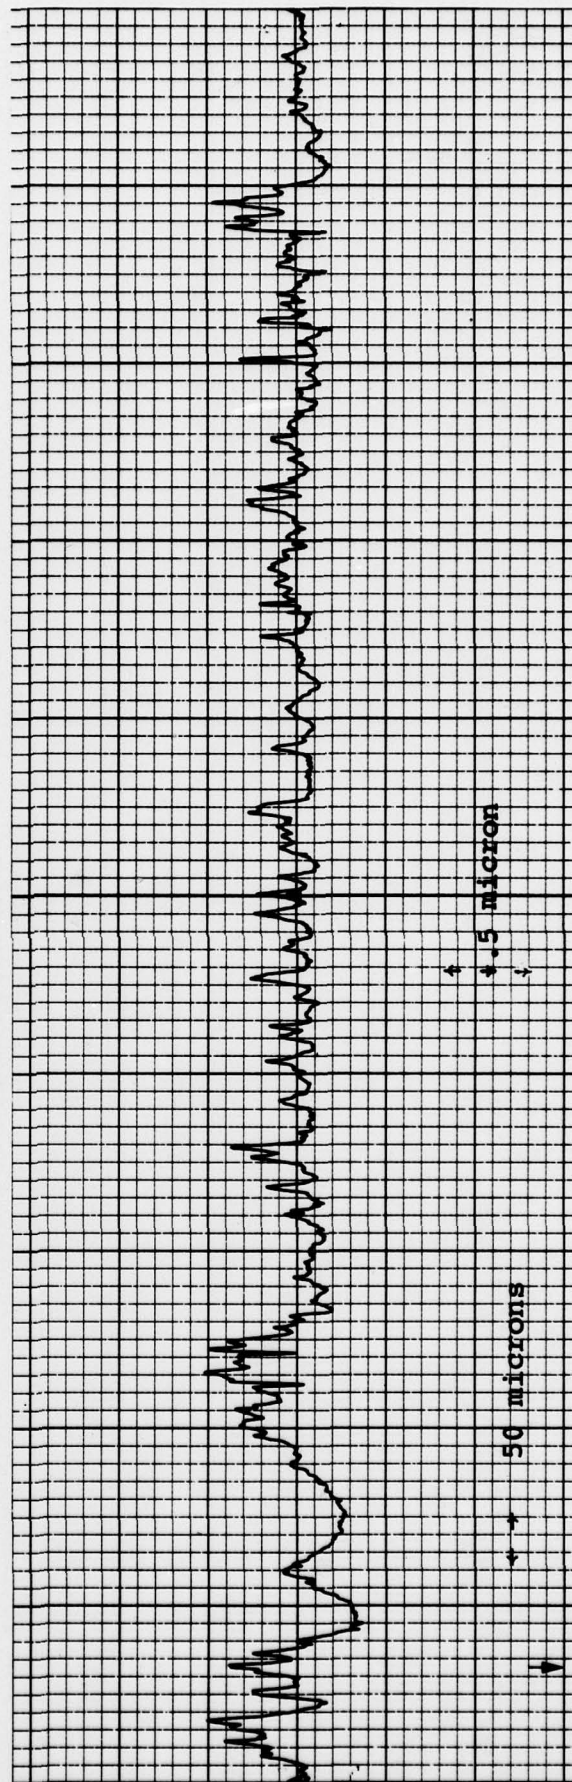
Figure 32 - Surface Profile Trace with Stylus Traversing Parallel to Rolling Direction
